MANITOU SPRINGS FLOOD HAZARD MITIGATION PLAN

Summer 1985

Center for Community Development & Design

**University of Colorado
Colorado Springs**

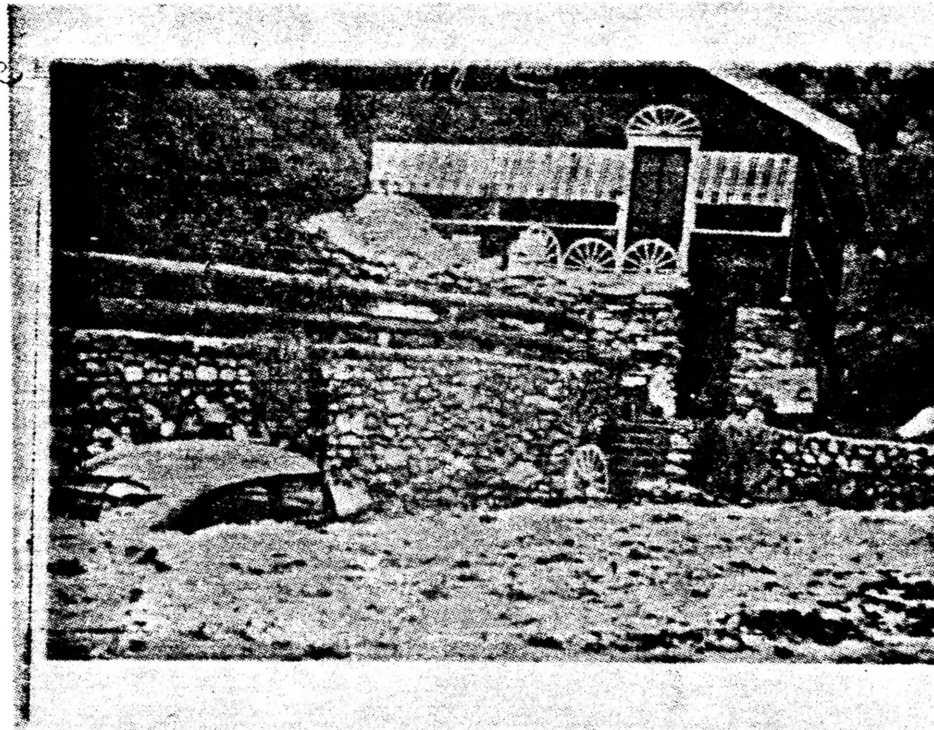
Figure 6. Debris deposits left along Canon Avenue in the aftermath of the torrent of water exiting Williams Canon.

The Colorado Springs Free Press of May 12, 1947 stated that "Mayfair Bridge was destroyed...Cottonwood Camp and Greenwich Village Court as well as other campgrounds bordering the stream received damage to grounds and surroundings...One person drowned when she stepped into an uncovered manhole along Canon Avenue near the Cliff House and was carried away...the amount of water flowing down the street made it impossible to see where the water pressure had lifted the cover off...Flow from Williams Canon continued to flow down Canon Avenue until late on May 11."

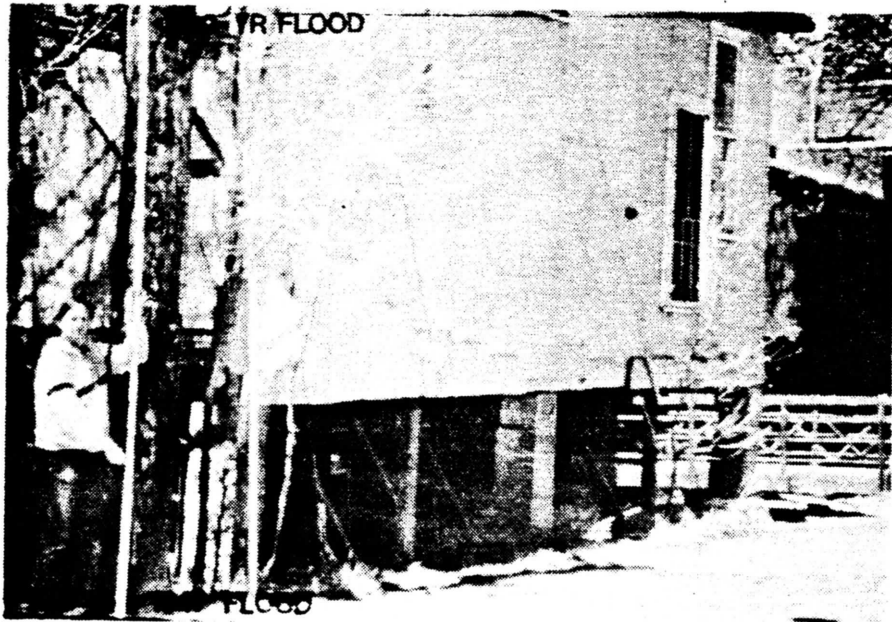
Figure 7. Flood elevations along Fountain Creek adjacent to Lover's Lane Bridge.

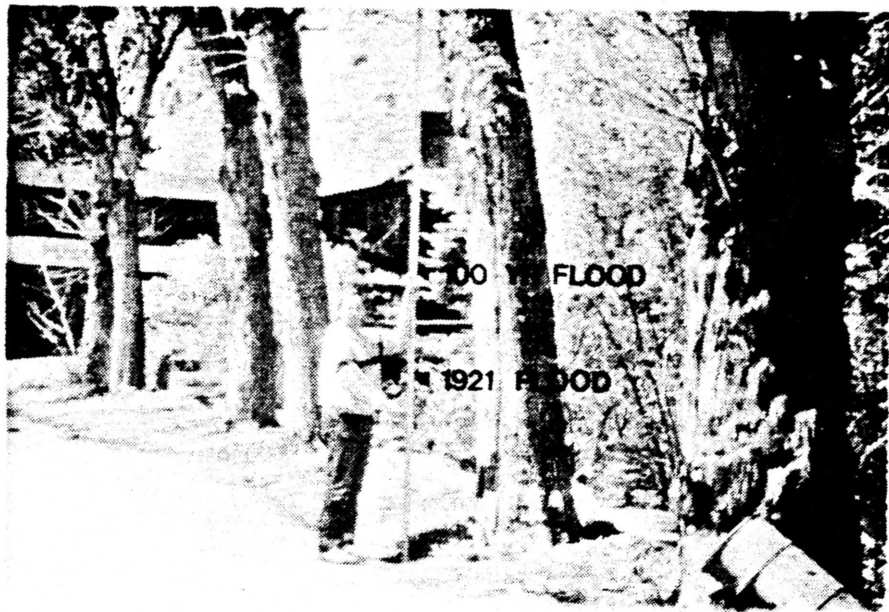
Figure 8. Flood elevations along Ruxton Creek just below the Iron Springs Chateau.

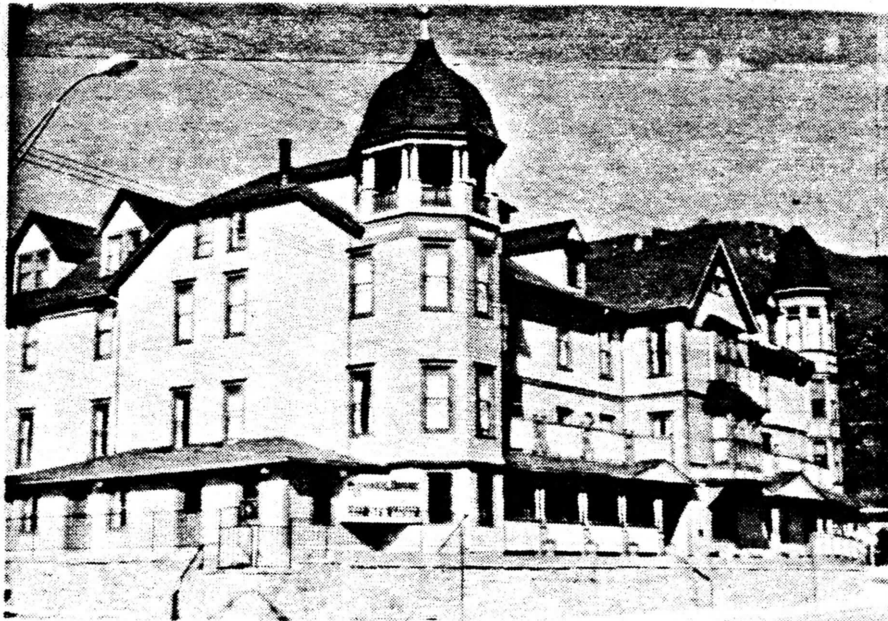
Figure 10. Barker House (formerly the Navajo Hotel) along Manitou Avenue showing the Elevated Entries and Protective Floodwall.

The third option is structural floodproofing. Here again, an historic structure's designation may be jeopardized if visible changes made to resist flooding are too significant. Therefore, any proposed floodproofing design needs to be coordinated with representatives of the national and state historic registries to protect the property's historic designation.

Provisions have been made in the National Flood Insurance Program which recognize the historic character of an area and allow for variances to be issued by a community for the "reconstruction, rehabilitation or restoration of structures listed on the National Register of Historic Places or a State Inventory of Historic Places, without regard to the procedures set forth..." (Federal Emergency Management Agency, 1984b). This provides that a building listed on the National Register or State Inventory which is damaged in a flood may be rebuilt in the same location regardless of the degree of damage and whether or not the property is located in either the floodway or floodfringe. Whether listed individually or as contributing to an historic district, buildings on the National Register of Historic Places have the same status (Abele, 1985) and would all be subject to the variance discussed above. However, if a structure receives damage to an extent greater than 50% and is consequently rebuilt, its historic character may be questioned. The Advisory Council on Historic Preservation would then have to determine on an individual basis whether the property and structure should be retained on the National Register.
